# Investigation Report

Type of Occurrence:	Accident
Date:	12 June 2011
Location:	Reichelsheim
Aircraft:	Airship (Blimp)
Manufacturer / Model:	American Blimp Corporation / A-60+
Injuries to Persons:	1 person fatally injured, 3 persons suffered minor injuries
Damage:	Aircraft destroyed
Other Damage:	Minor crop damage
Information Source:	Investigation by BFU
State File Number:	BFU CX004-11

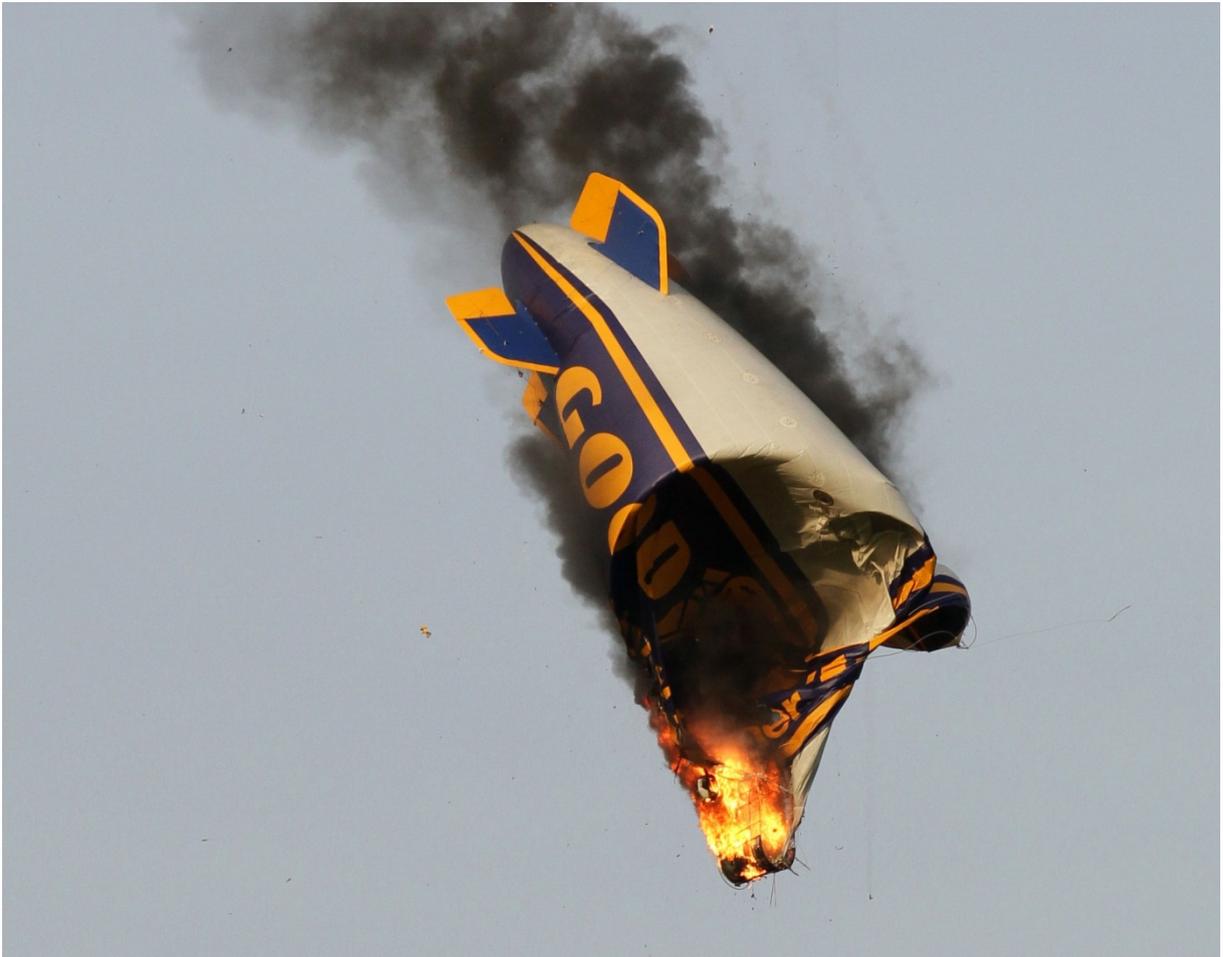
The burning airship continued to ascend again up to about 100 m and thereby drifted slowly to the east. Deformation of the envelope began with the increasing fire. Later it caved in and at 2020 hrs the burning airship crashed to the ground about 400 m from the initial touch-down point. It burnt out completely and only the pilot's body could be recovered. The three persons who had left the airship suffered from shock.

Burning airship

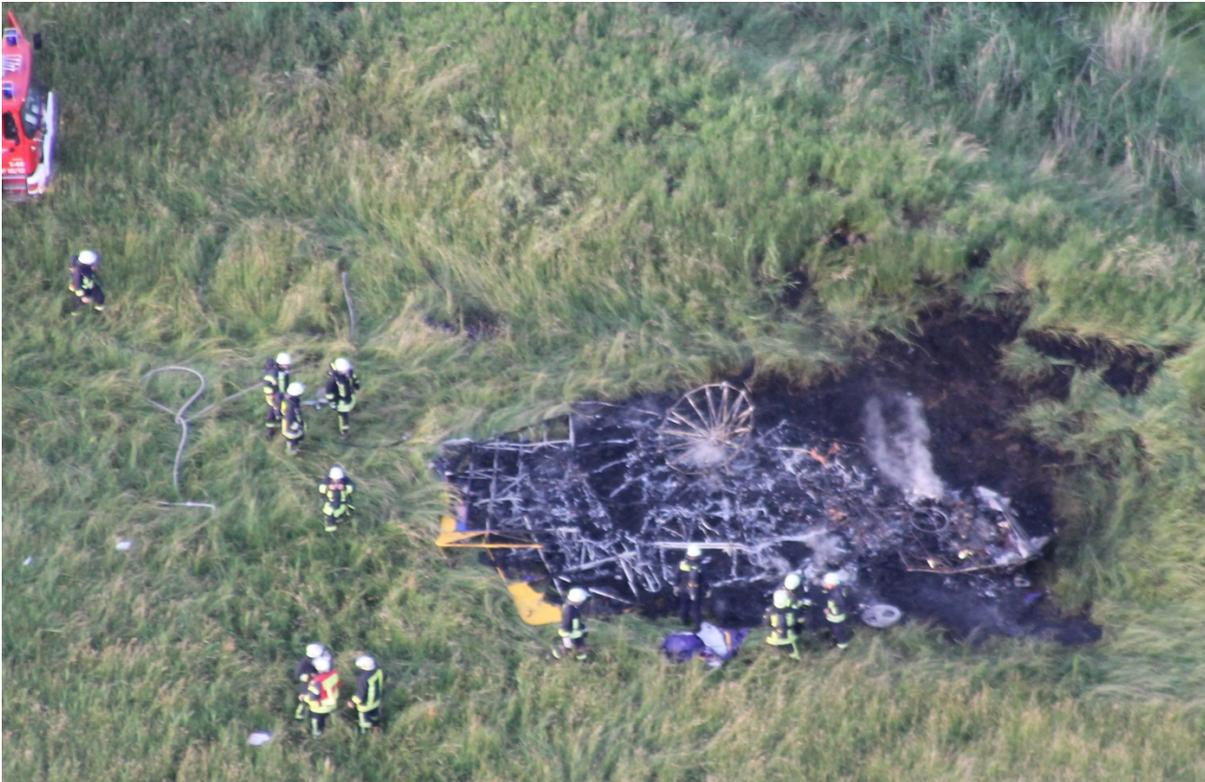
Accident site airship

The accident site was located about 500 m east of the asphalt runway on a meadow. On the ground the entire airship construction had burnt almost completely. Only the metal construction of the envelope and the gondola protruded from the accident site. The steel tube frame work was severely deformed. A slit-shaped opening was found on the bottom of the fuel tank. The edges of the 23 cm long opening were clearly bent inwards. For further investigation, the torn-off landing gear and gondola components were taken to Braunschweig.

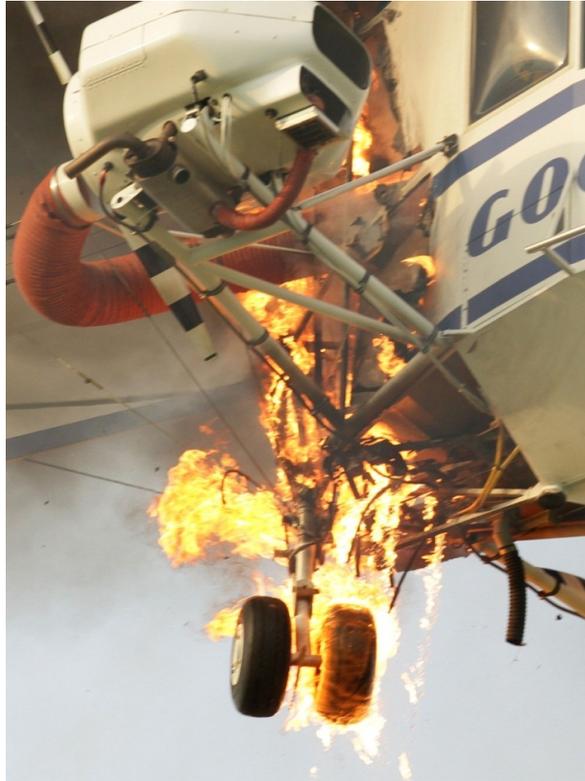
After the airship touched down hard there was fuel leakage which caught fire on the rear part of the gondola.

Source of the fire on the gondola

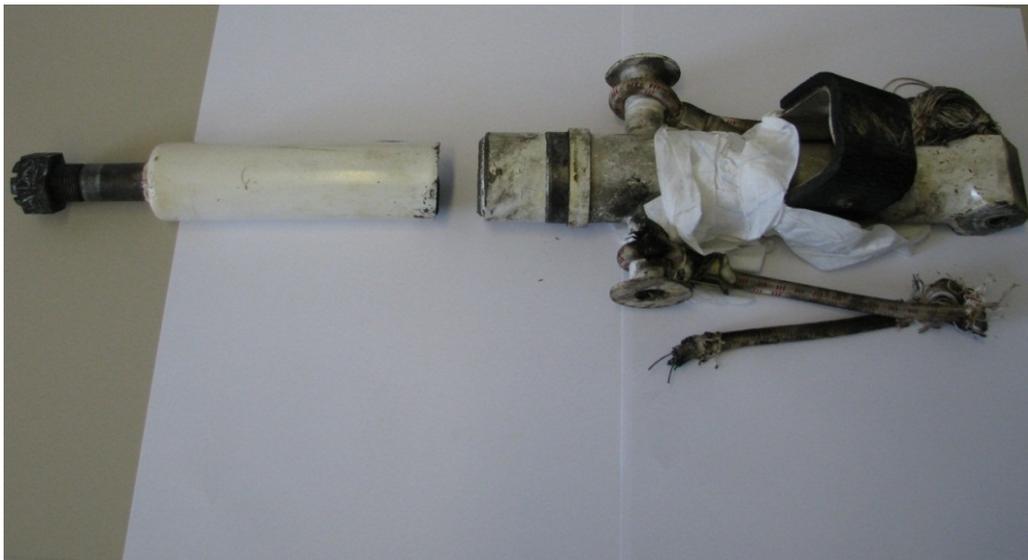
The landing gear fractured at the landing gear strut. The fracture is located 40 mm above the lower bearing ball. In this area was a shoulder where the outer diameter of the landing gear strut was reduced from 57 mm to 51 mm. Due to the shoulder the change in wall thickness causes a change in stiffness which increases the predisposition for fracture.

Fractured landing gear strut

At the fracture surface shear lips of 45° had formed. It was decided that the foremost point of the outer diameter of the strut is in the 12 o'clock position when landing gear and flight direction are aligned. Based on this decision the shear lips appear in two areas. One area extends from 7 to 5 o'clock. In this area the shear lips run 45° from outer to inner diameter. In the area between 5 and 7 o'clock they run 45° from inner to outer diameter.

This fracture pattern indicates a forced fracture which occurred with high tensile stress. There were no indications that the fracture occurred over a longer period of time. At the cross section, the fracture occurred abruptly from the front to the back. The landing gear was hit from the front during forward motion. Since the landing gear

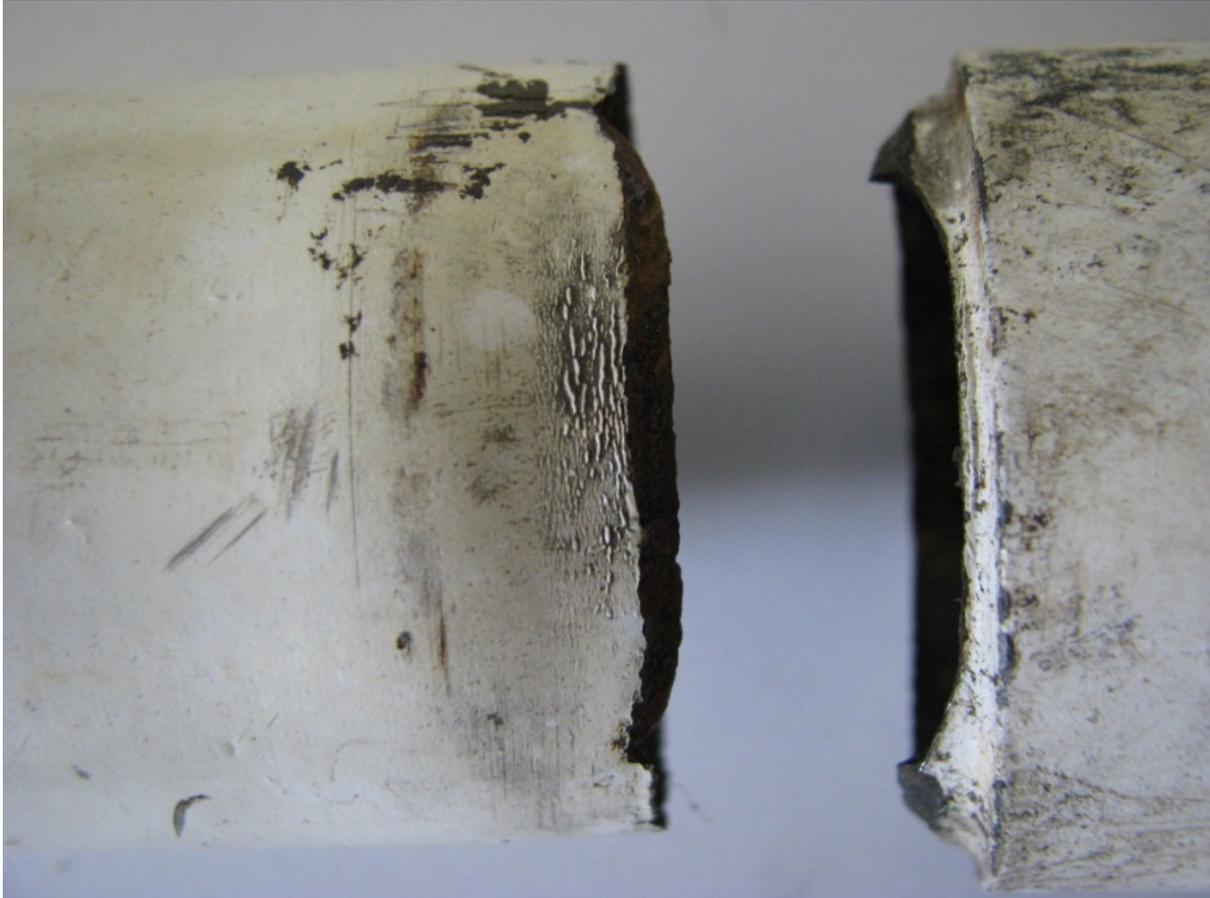
strut was restricted in its movement by the position of the ball bearings in the stay tube bending was not possible and therefore the strut was strained to tension. Only after about two thirds of the strut were fractured the characteristic buckling of a bent tube appeared on the back of the upper fracture surface.

Fracture of the landing gear strut from the back with the buckling on the left fragment

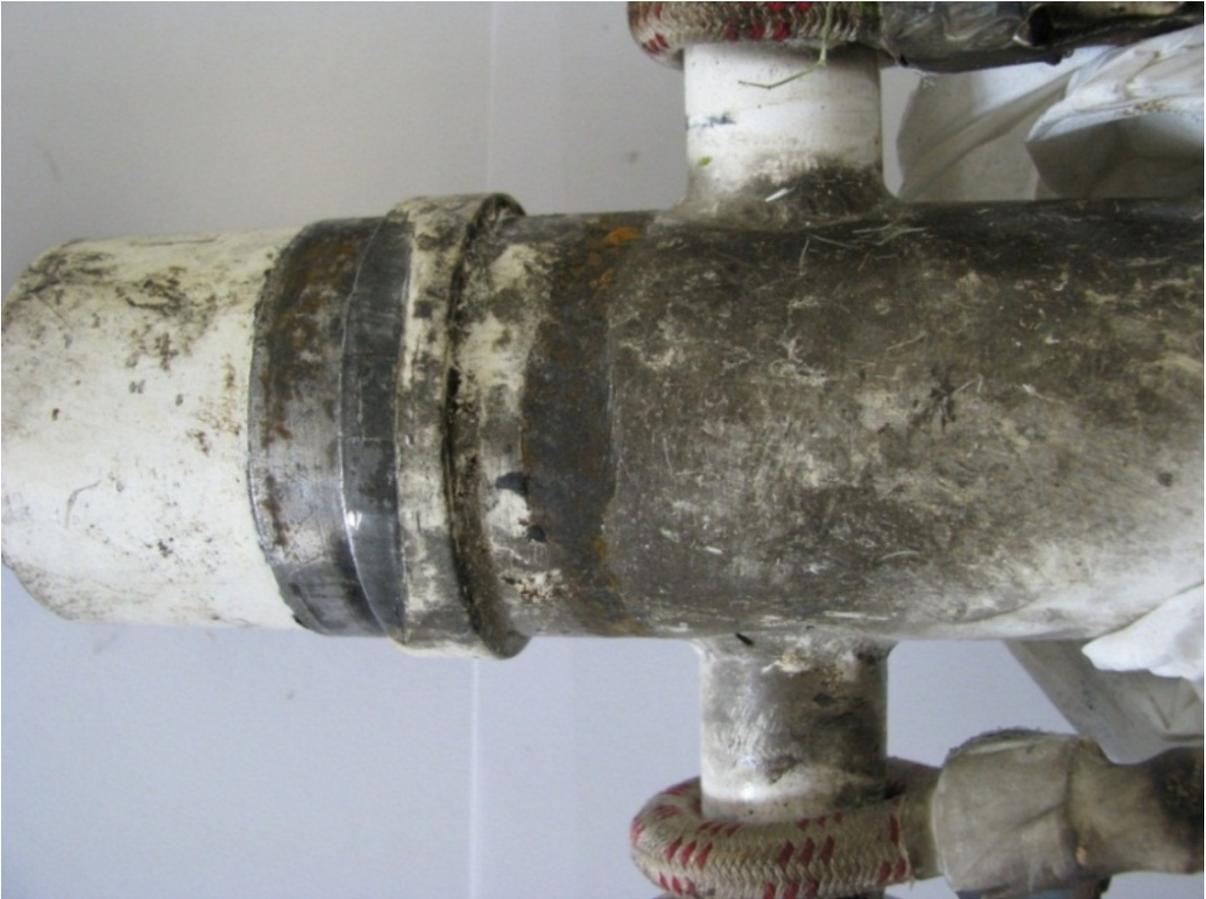
At the lower seat of the ball bearings, the balls had indented themselves into the back side of the stay tube between the 4 and 8 o'clock positions. The cross section of the stay tube was pulled out to the rear and therefore somewhat oval instead of round.

Bottom fracture piece of the landing gear strut with ball bearing seat

The abraded paint is an indication that the front side of the lower fracture piece of the landing gear strut grated on the front side of the stay tube's inner side. The collar on the landing gear strut limits the lower ball bearing seat downward. Its back side was forcibly pressed back into the upper ball bearing seat, located on the stay tube. This caused the paint abrasion. Due to this forced indentation the balls mapped themselves on the upper ball bearing seat of the stay tube.

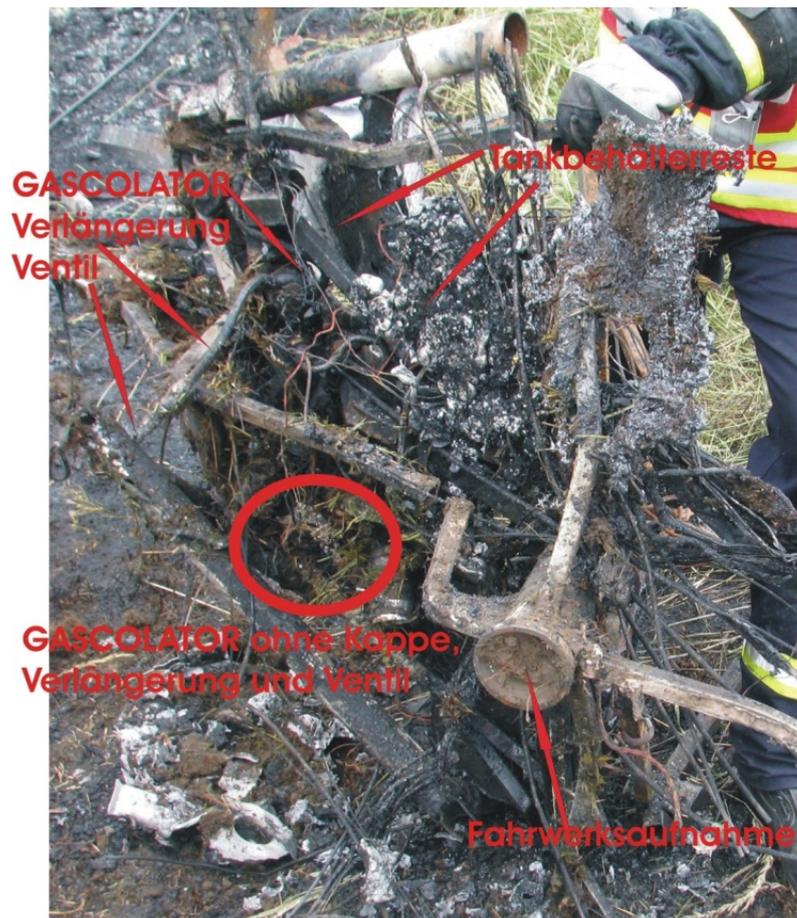
Steel tube frame work with stay tube and fuel tank parts at the accident site

Although the components were severely damaged the position of the gascolators could be determined. On one of the bowls the closing cap including extension hose and drain valve were missing.

The examination of the remaining parts of the fuel tank at the accident site revealed a gap of about 23 cm on the bottom part of the fuel tank. The investigation determined that as the burning wreckage crashed to the ground the tetragonal steel pipe construction was pushed into the bottom of the fuel tank.

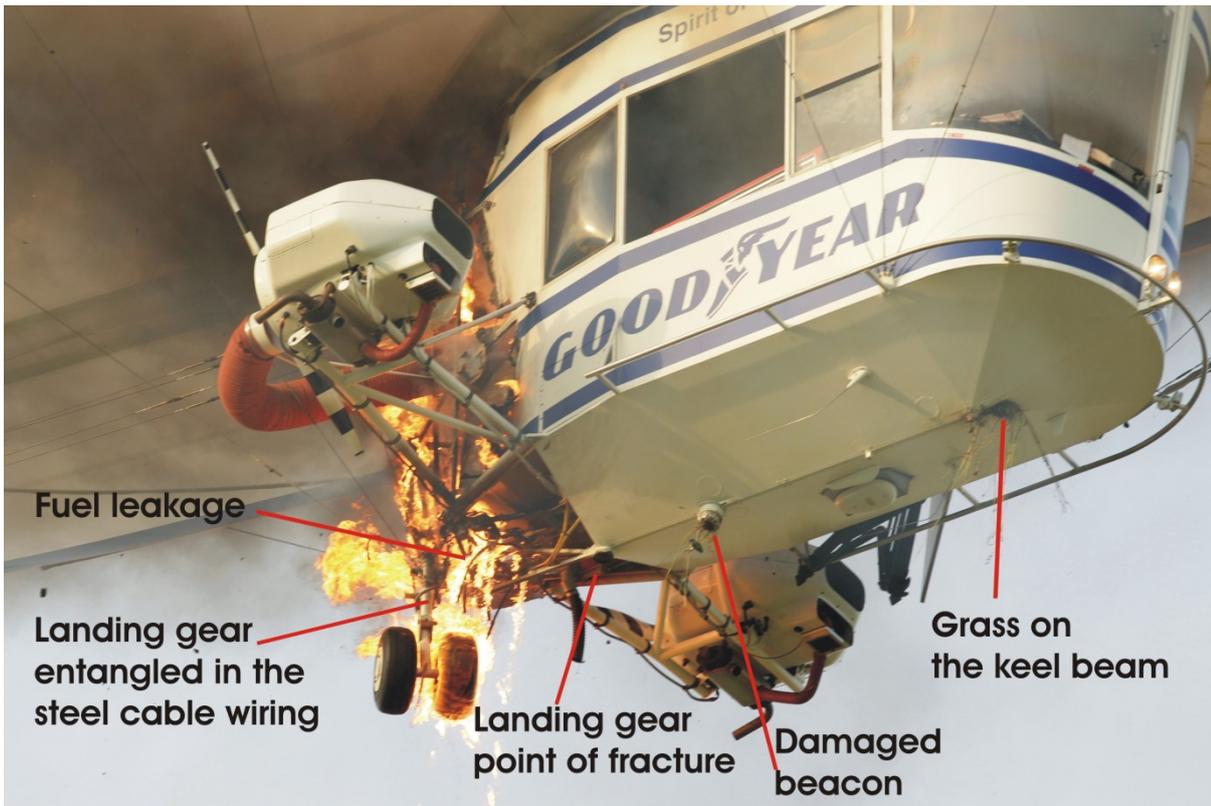
Burning gondola

On photos taken at the time when the airship began to ascent again flames dripped down where the gascolators were located and burning liquid (fuel) is visible.
