# Investigation Report

Type of Occurrence:	Accident
Date:	12 June 2011
Location:	Reichelsheim
Aircraft:	Airship (Blimp)
Manufacturer / Model:	American Blimp Corporation / A-60+
Injuries to Persons:	1 person fatally injured, 3 persons suffered minor injuries
Damage:	Aircraft destroyed
Other Damage:	Minor crop damage
Information Source:	Investigation by BFU
State File Number:	BFU CX004-11

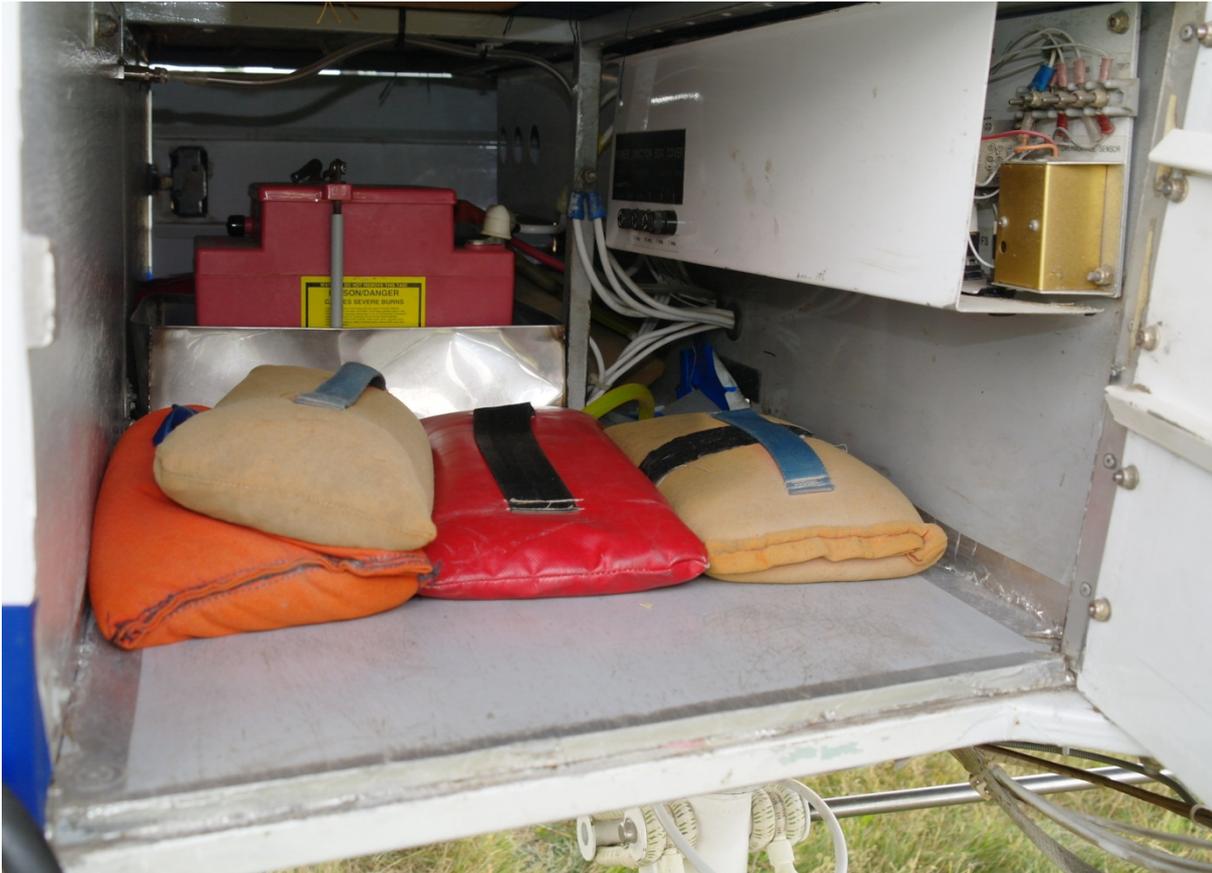
The sister airship (same design)

A ballast compartment is located in front of the fuel tank in which additional ballast bags can be transported and where the starter battery is installed. On the bulk-head inside the compartment a special mounting for electrical wires and components is installed. Several wires run through the back wall of the ballast compartment into the open space below the rear end. These wires run on both sides of the fuel tank to the outside. Among other things, a charging station on the upper left is connected to it.

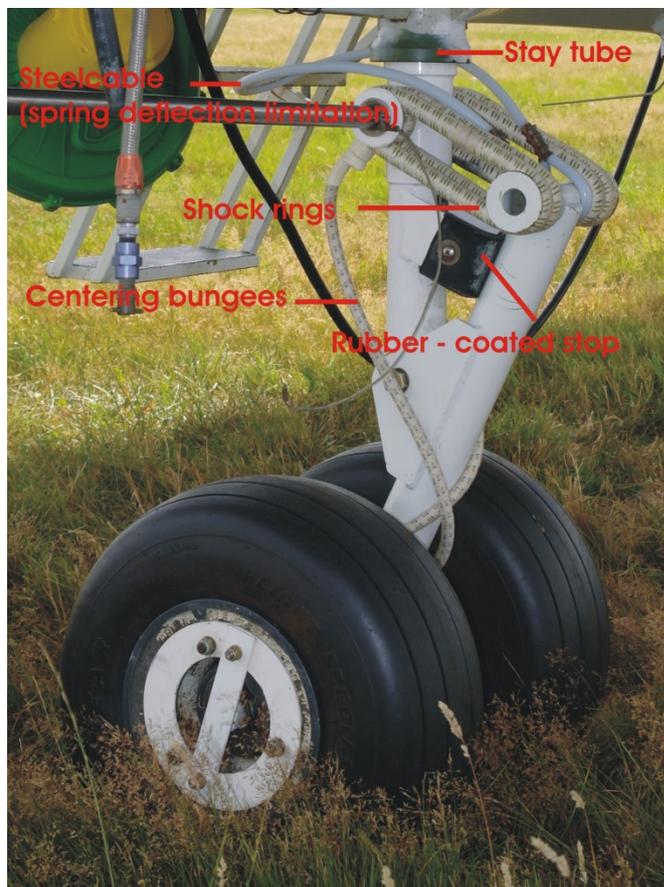
Sister airship

The landing gear consists of a landing gear strut which is designed as a tube. It is inserted into a stay tube from below and its upper end is bolted down with a crown nut.

In the unloaded condition spring deflection is limited by a rubber-coated stop which is welded to the landing gear strut. This also keeps the axis centre behind the centre line of the strut and therefore ensures that the spring mechanism is triggered. Maximum spring deflection is limited by a steel cable; it begins at the brackets for the shock rings on the landing gear leg and goes around the strut. In addition, two centering bungees are stretched between the brackets for the shock rings and the gondola undercarriage; they align the landing gear with the flight direction.

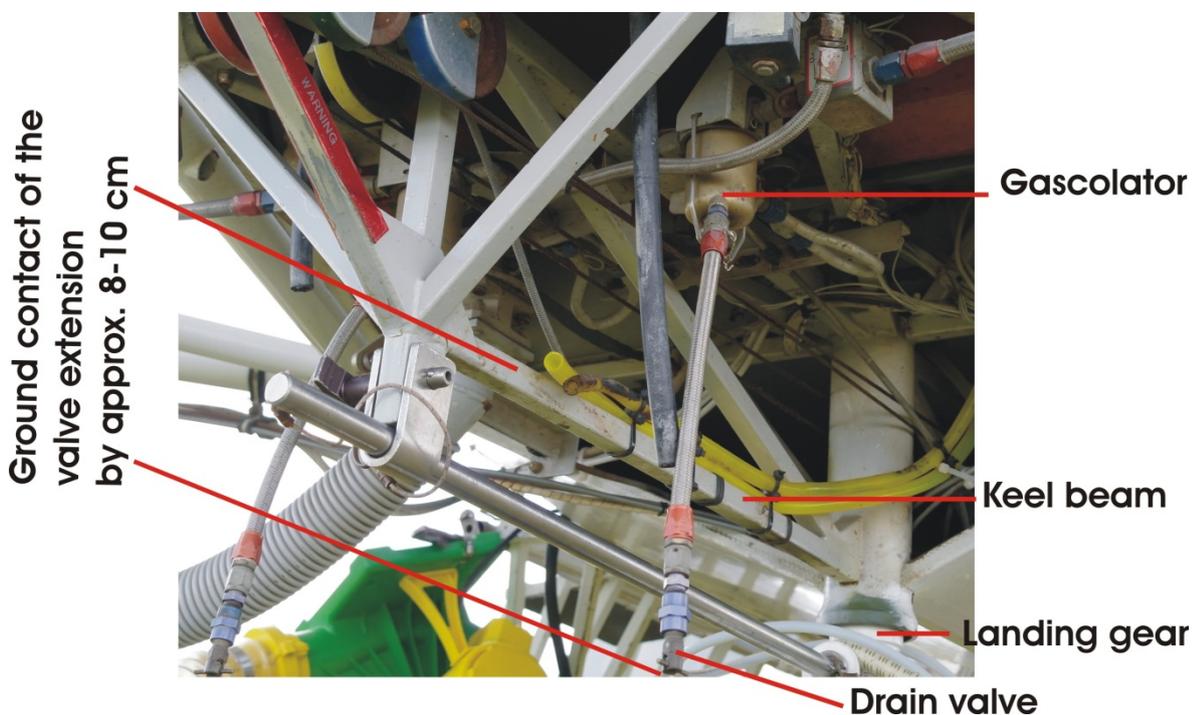
Sister airship

At the outside rear of the gondola a fuel tank holding 260.8 l fuel was installed. From the fuel tank, fuel pipes led to both engines.

Two gascolators were mounted to the bottom of the fuel tank, each of which was equipped with a 33 cm long flexible fuel pipe and one drain valve. Whenever the bottom of the gondola rests on the ground the valve extension of the drain valve inevitably has ground contact on a length of 8 - 10 cm.
